# Evaluation Of The Silver Tarnish Problem, Launch Processing System

TEST REPORT

National Aeronautics and Space Administration  
Kennedy Space Center  
Materials Testing Branch

The Materials Testing Branch was requested to evaluate the effects of silver "tarnishing" of components of the Launch Processing System. The area of most significant concern found is the "tarnish" effects on the wire-wrap wires of the older LPS circuit boards. If maintained in the proper environment the LPS hardware could be expected to have a significantly extended operational life, despite the relatively poor quality of some hardware.

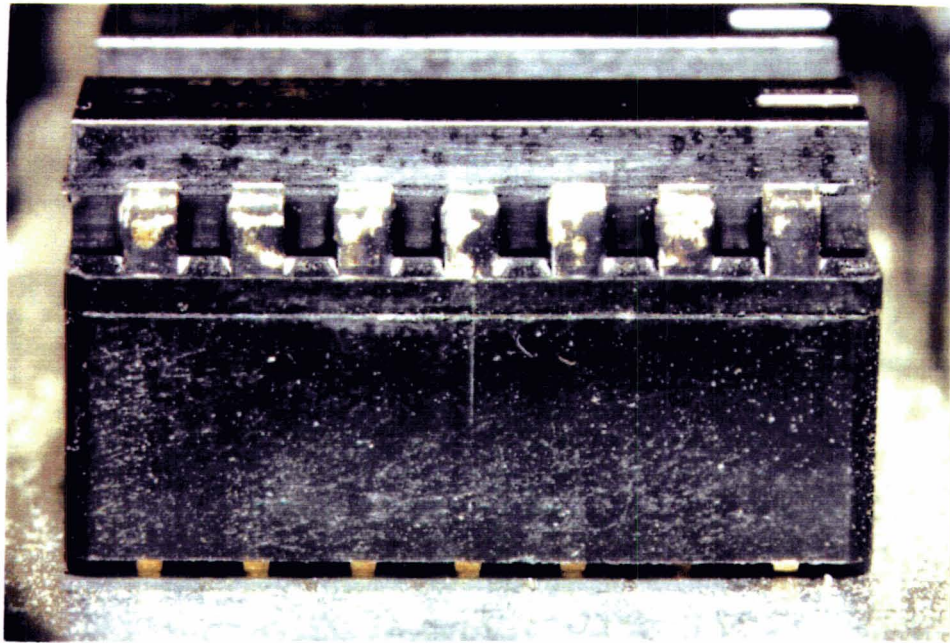
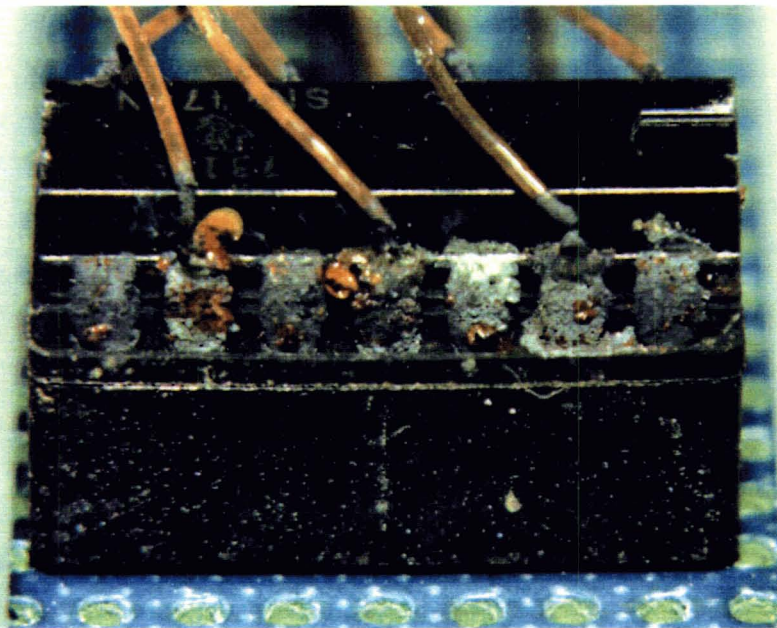
FIGURE 6-1

- 6.5 From the environmental tests, contact resistances as high as 19 ohms were obtained with the Ag plated IC pins. These conditions were not necessarily the result of Ag tarnish, but from a combination of the high humidity, poor quality Ag plating, and the corrosiveness of the pin substrate material. Figure 6-1 illustrates the gross difference between a heavily tarnished IC from Board No. 1 and a corroded test specimen.

IC WITH TARNISHED PINS INSTALLED ON 12 YEAR OLD BOARD NO. 1 AS RECEIVED BY THE MTB.

IC WITH CORRODED PINS ON TEST BOARD ABT1 AFTER ENVIRONMENTAL TEST.

THE DIFFERENCE BETWEEN HEAVILY TARNISHED IC PINS (TOP) AND THE CORRODED TEST SPECIMEN WHICH PRODUCED CONTACT RESISTANCES AS HIGH AS 19 OHMS (BOTTOM) IS ILLUSTRATED.

- 6.6 The test results emphasize the need for environmental controls in the LPS area. In addition to controlling the sulfides entering the LPS areas, humidity, temperature, and other contaminants should be controlled.
